Rectifying the Tooth Preparation Errors in All-Ceramic Restorations

All-ceramic restorations have been used for long as restorative material in dentistry. However, the recent advances in both the material and technology of all-ceramic have made them a more viable treatment option. Several practitioners hesitate in giving this option to patient for fear of failure. This article describes all the failures of all-ceramic material and how to prevent them. In particular, the article highlights various errors that clinicians make while preparing tooth to receive all-ceramic restorations and how to rectify them.

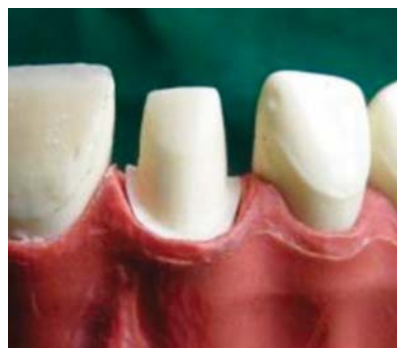
Fig. 1A: Sharp line angle and point angle

Leaving behind sharp line angles and point angles in the preparation can lead to major fit problems and time consuming appointment at the time of cementation. Sharp line angles form potential sites for fracture stimulation of all-ceramic restoration²²⁻²⁵ (Fig. 1A). The solution is simple. One must round off all the sharp line angles and point angles at the time of tooth preparation (Fig. 1B).

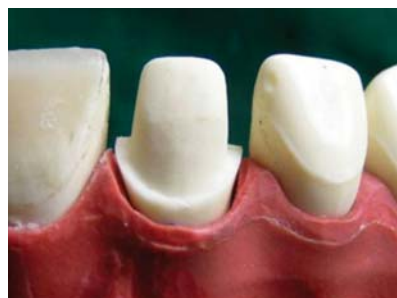
Fig. 1B: Rounded line angle and point angle

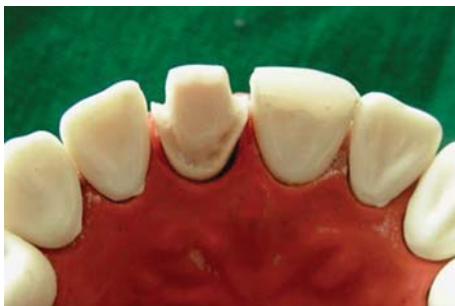
Fig. 3: Rough shoulder

Rough shoulders are not just difficult to record but also difficult for the technician to work on. They contribute to unnecessary build-up of stresses at the margins. A smooth shoulder ensures an excellent fit, minimal cement line and good esthetics. Also, undue stress at the margins arising from rough shoulder is avoided (Fig. 3). An end-cutting diamond must be run over the margins at the end of the preparation to smoothen the margins.²⁶

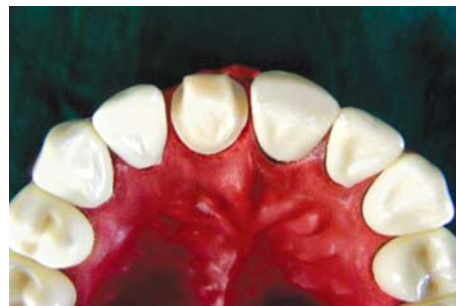
Fig. 5: Nonuniform shoulder

If the width of the shoulder varies from one region to another, it can vary the ceramic thickness with a potential for premature

fracture during fabrication, seating or cementation²³ (Fig. 5). This can also cause an undesirable esthetic failure. To avoid this failure, one must prepare a uniform shoulder of 1 to 1.5 mm all around the tooth.

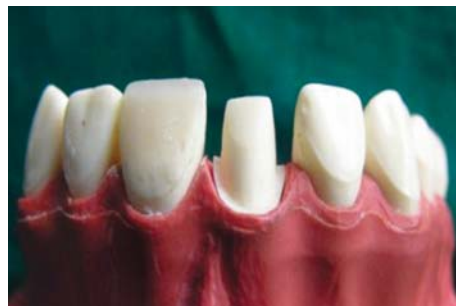
Fig. 6: Sharp internal line angle

Clinician often tends to underestimate the importance of smooth internal line angle lying at the junction of axial walls and margins. A sharp internal line angle can cause undue stress, initiate fracture and may cause fit problems^{23,24} (Fig. 6). To prevent this problem, it is advisable to use a flat end diamond with built in round edges, which automatically creates a rounded internal line angle while creating a shoulder margin.

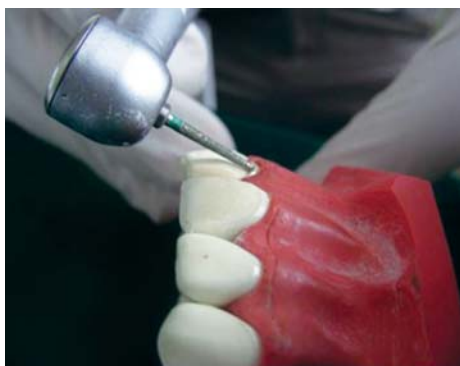
Fig. 7A: Faulty orientation of the diamond

This is created when the operator loses orientation to the proper plane of reduction and angulates the head of the diamond too deep into the margins (Fig. 7A). The end result is a deep undercut and not a shoulder.²³ Although it appears as a shoulder in one plane it is a false appearance. A pseudoshoulder can diminish both the strength and esthetics of the ceramic (Fig. 7B). Use of depth orientation groove will keep the operator oriented to the right plane of reduction.

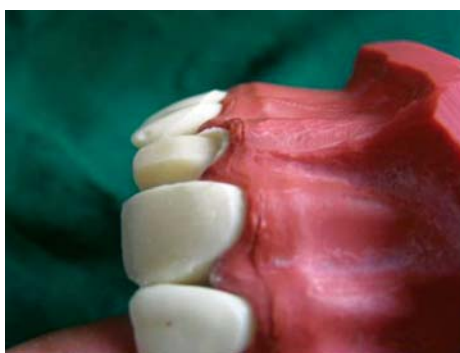
Fig. 7B: Pseudoshoulder
