Management of Horizontal and Multiple Crown-Root Fractures

This report records the case of intraalveolar horizontal root fracture with subluxation of coronal segment, treated with Mineral Trioxide Aggregate (MTA) barrier and effective management of crown-root fracture using custom cast post.

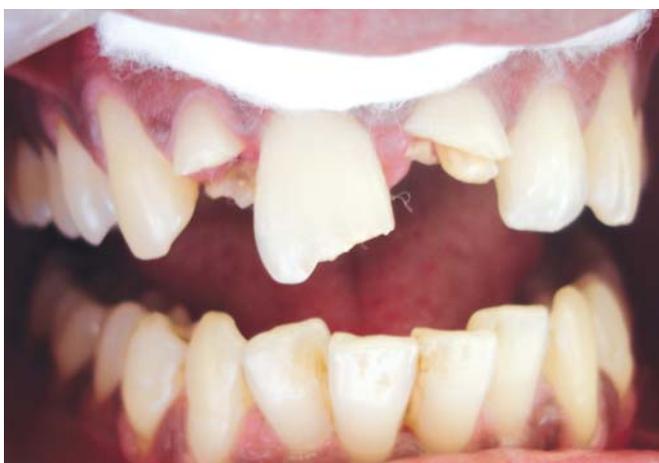
A 24-year-old male patient was presented to the Department of Conservative Dentistry and Endodontics, Bangalore Institute of Dental Sciences and Research Center, after 15 days of traffic accident with a chief complaint of multiple front teeth fracture (Fig. 1). On clinical examination, tooth 11 showed Ellis class I fracture with grade III mobility. Probing depth was 2 mm and demonstrated no response to vitality test

Fig. 1: Preoperative clinical photograph showing crown-root fracture

The treatment plan comprised of reduction and rigid splinting in relation to 11 and removal of mobile palatal fragments in relation to 12 and 21, followed by root canal treatment. Tooth 11 was splinted using 0.6 mm stainless steel orthodontic wire bonded with composite resin. Root canal treatment was performed in relation to 12 and 21. A decision of endodontically treating only the coronal fragment in relation to 11 was taken, as the fracture fragments were not approximated and due to the possibility of the apical fragment retaining pulp vitality.⁵ Working length determined was about 17 mm (Fig. 3). MTA (Proroot MTA, Dentsply, India) plug was placed into the apical 4 mm of the coronal fragment after cleaning and shaping, using endodontic pluggers (Fig. 4). After 24 hours, rest of the canal was obturated with warm vertical compaction of gutta percha. Four days later, the access cavity was restored with composite resin.

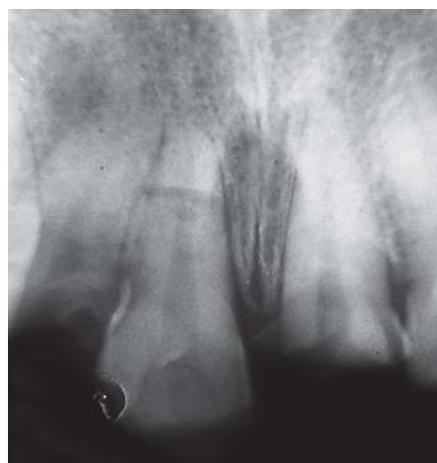
(thermal and electric pulp testing). Teeth 12 and 21 showed complicated oblique crown-root fracture with shattered crown and grade III mobility of palatal fragments. Intraoral periapical radiograph showed intraalveolar horizontal root fracture, at the junction of middle and apical third of the root with subluxation of coronal fragment in relation to 11 (Fig. 2). With respect to teeth 12 and 21, the fracture line extended below CEJ and alveolar crest.

Fig. 2: Preoperative radiograph showing horizontal root fracture

Healing of root fracture without treatment has been reported in many case reports.^{1,12,13} In the present case, tooth 11 had lost its vitality, probably due to luxation of coronal fragment. Radiographically, space between the fragments was persistent even after splinting, suggestive of granulation tissue preventing reduction. So, root canal treatment was initiated limiting to coronal segment. It was decided not to treat the apical fragment,

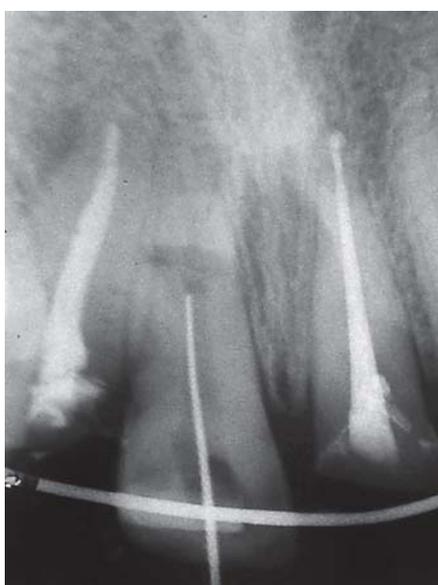
Fig. 3: Working length determination

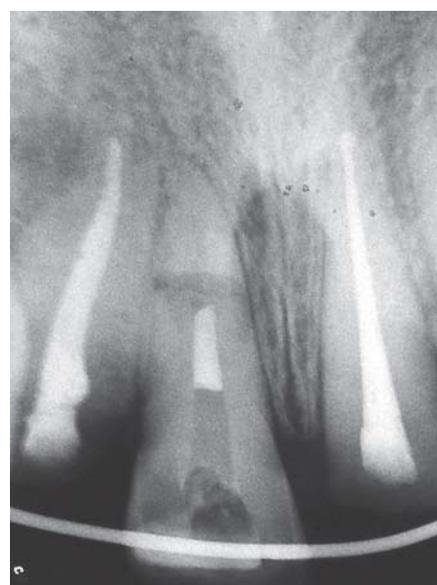
Fig. 4: MTA placement

as apical fragment almost always contains vital pulp tissue and invariably scleroses.^{5,14} Rarely, they may require surgical removal (Fayle, 1999; Saroglu and Sonmez, 2008). Coronal segment needs to be treated like a tooth with large apical exit. It would become difficult to limit the obturating material without an apical barrier. Here, we used MTA as a barrier at the coronal aspect of the fracture line similar to apexification procedure. In addition to having excellent biological and physical properties, it has shown to induce regeneration of periapical tissue and hard tissue deposition.^{15,16} MTA also shows excellent marginal adaptability and is nonresorbable.¹⁷ Follow-up radiograph of this case report confirmed repair of root fracture with mostly hard and connective tissue interposition and there were no signs of resorption or periapical pathology (Fig. 7).

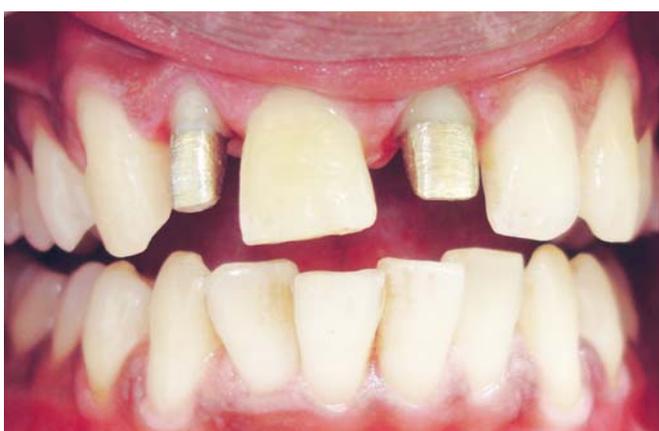
Fig. 5: Cast posts cemented

The patient's postoperative course was uneventful. Rigid splint was removed after 2 months of follow-up. Mobility was within normal limits. After performing crown lengthening to expose the fracture line, teeth 12 and 21 were restored with custom cast post and core (Fig. 5). Chamfer finish line was placed

In case of oblique crown-root fractures, the fracture line begins a few millimeters incisal to marginal gingiva facially, then progressing obliquely below the gingival crevice lingually.² In the present case, teeth 12 and 21 showed similar presentation with palatal fragment displacement and mobility. These fragments were removed to allow gingival healing prior to restoration. To convert subgingival fracture line to supra-gingival, periodontal surgery (crown lengthening) was performed on palatal aspect to achieve predictable and faster results. Orthodontic extrusion could not be considered as a treatment option due to time constraints. After cementation of cast post, chamfer finish lines were placed on palatal portions of the cast core instead of the tooth surface. This was done to avoid violation of biologic width and to maintain root length. This also helped to achieve good marginal adaptation.

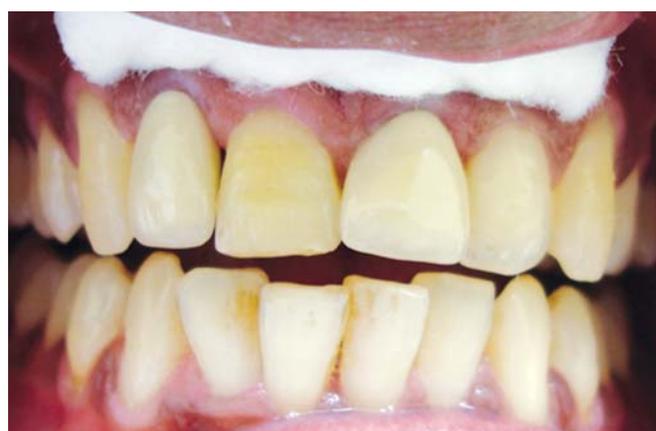
Fig. 6: Postoperative clinical photograph

on the cast core. Final restorations of porcelain fused to metal crown were given (Fig. 6).

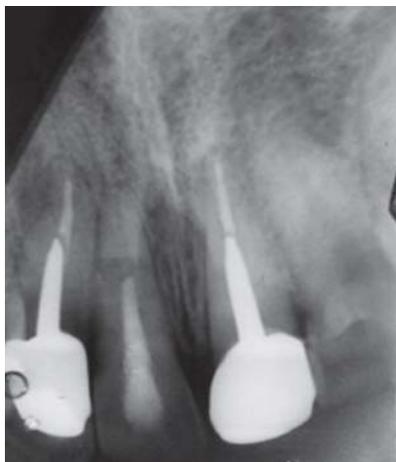
At recall visits of 3 months and 1 year (Fig. 7), teeth were asymptomatic and responded normally to palpation and percussion. There was evidence of healing at the fracture line in relation to 11 with normal periapical features.

Fig. 7: One year follow-up radiograph showing healing at the fracture site
